FOOD STORAGE WAREHOUSE

Seattle, WA

January 5, 1995

FIRE INVESTIGATIONS

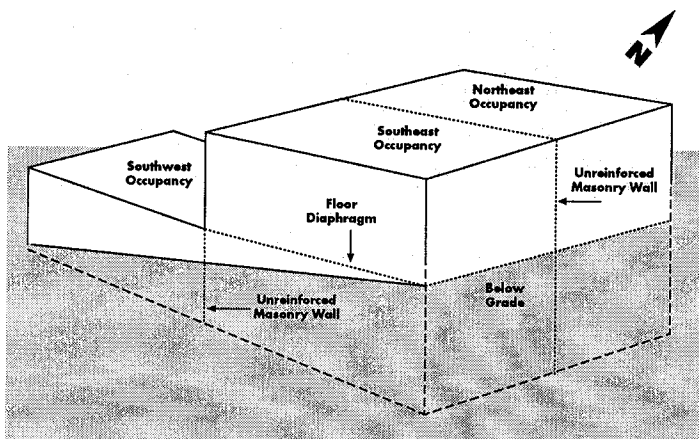
The warehouse in which the fire occurred was originally built in 1909 and had been modified a number of times over the years. According to plans provided by the City of Seattle Building Department, it had originally been a square structure. At the time of the fire, however, it was an L-shaped building occupied by a frozen food company, a bakery, and an unused warehouse.
